Photographs

Corrugated Metal Pipe Found To Be
Satisfactory or Unsatisfactory.

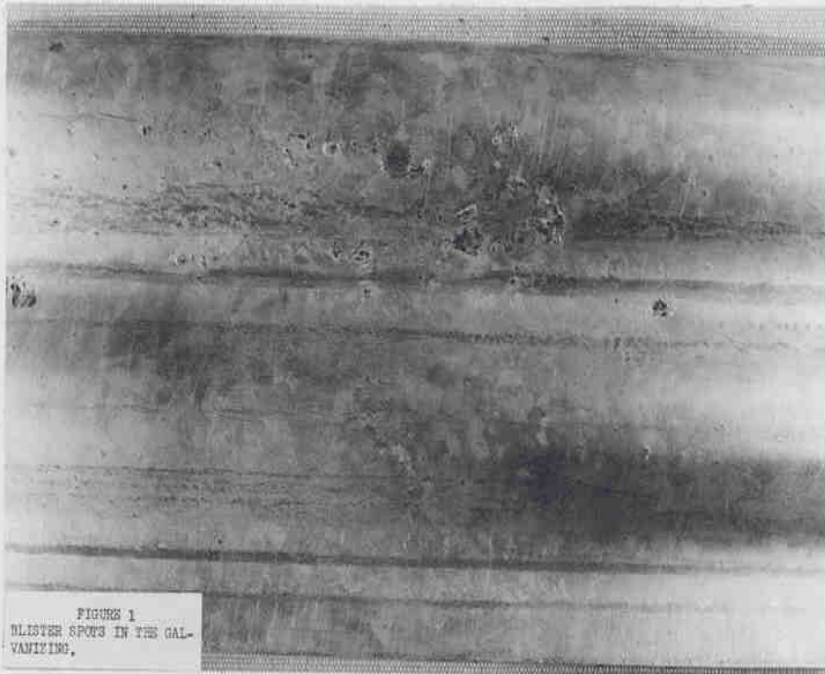
FIGURE 1
BLISTER SPOTS IN THE GAL-
VANIZING.

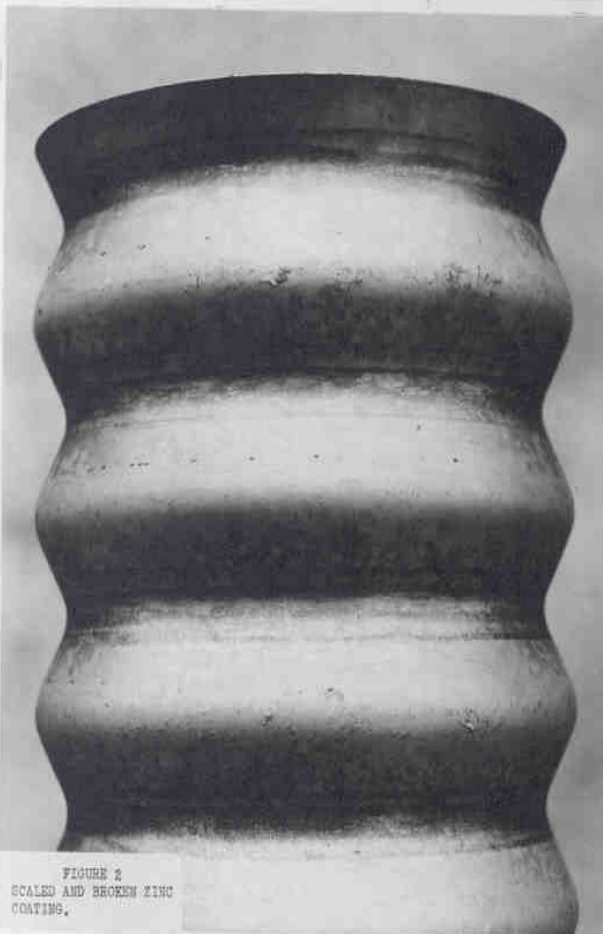
FIGURE 2
SCALED AND BROKEN ZINC
COATING.

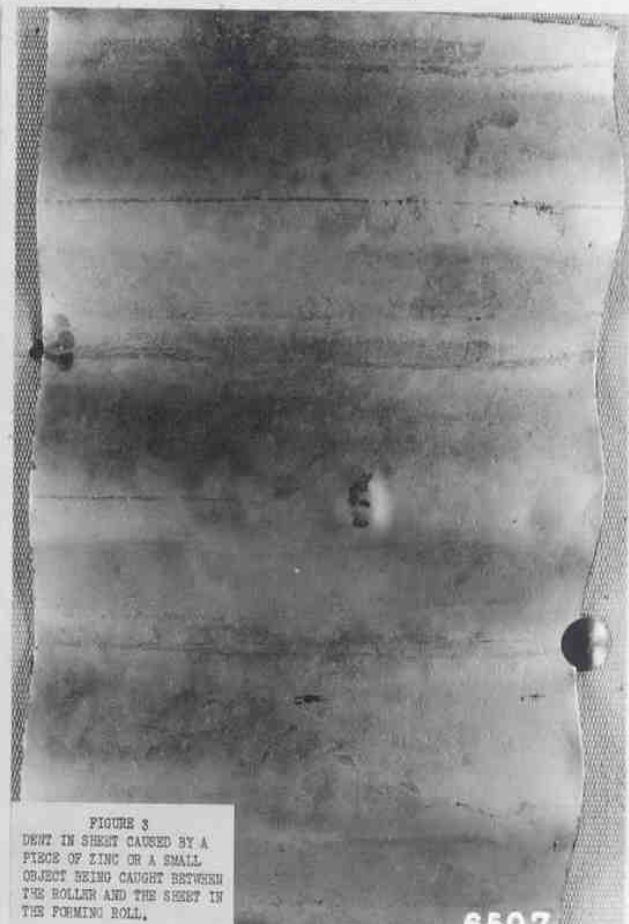
FIGURE 3
DENT IN SHEET CAUSED BY A
PIECE OF ZINC OR A SMALL
OBJECT BEING CAUGHT BETWEEN
THE ROLLER AND THE SHEET IN
THE FORMING ROLL.

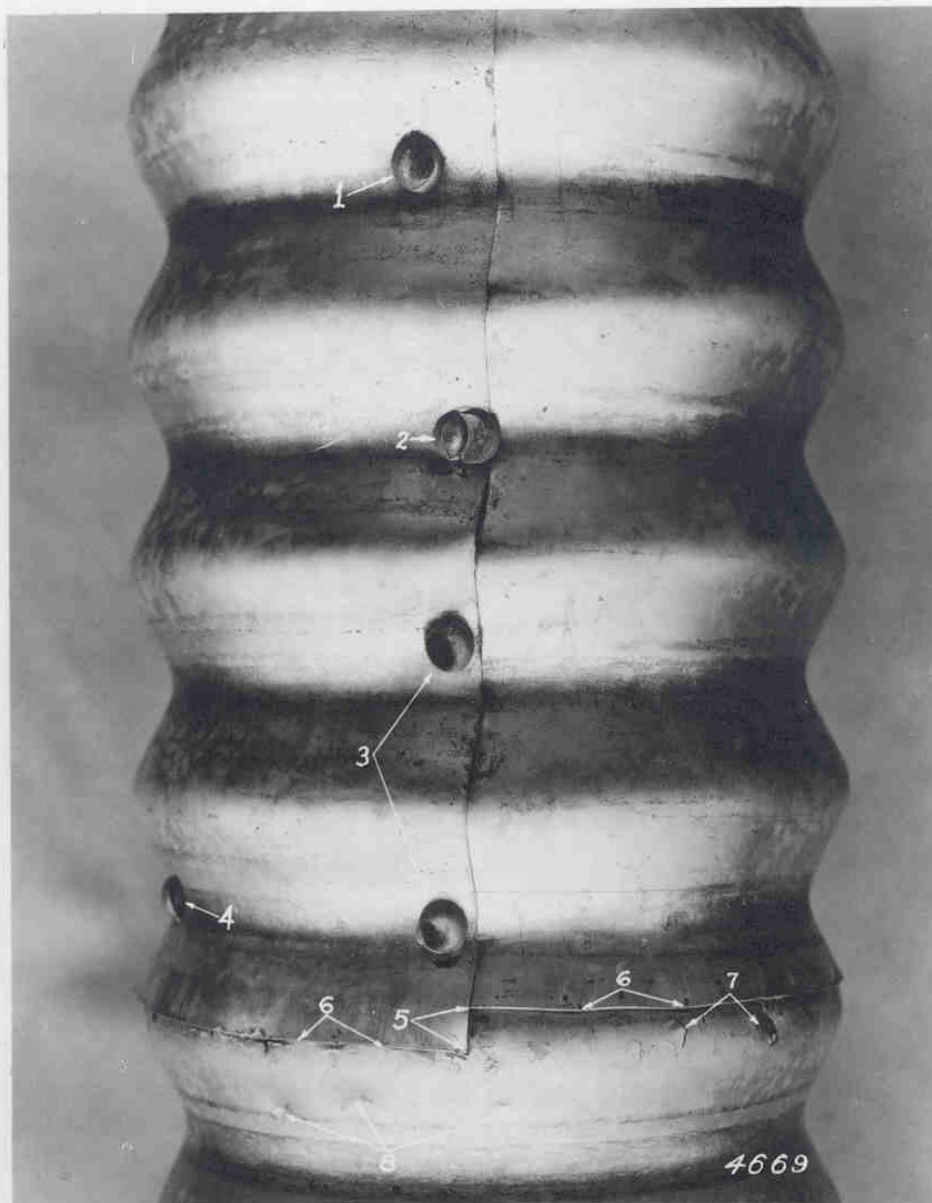
FIGURE 8
UNSATISFACTORY FABRICATION

1. Rivet Head Cut On One Side.
2. Rivet Head Badly Cut And Close To Edge Of Sheet.
3. Rivets Close To Edge Of Sheet.
4. Rivet Driven Very Crooked.
5. Very Poor Seam Caused By Uneven Sheet And Extra Wide Lip Which Flared Up Instead Of Fitting Tight Over The Lip On The Under Sheet.
6. Where Flare Was Hammered Down To Close The Opening Between Sheets.
7. Broken And Scaled Zinc.
8. Dents And Bruises Caused By Hammering.

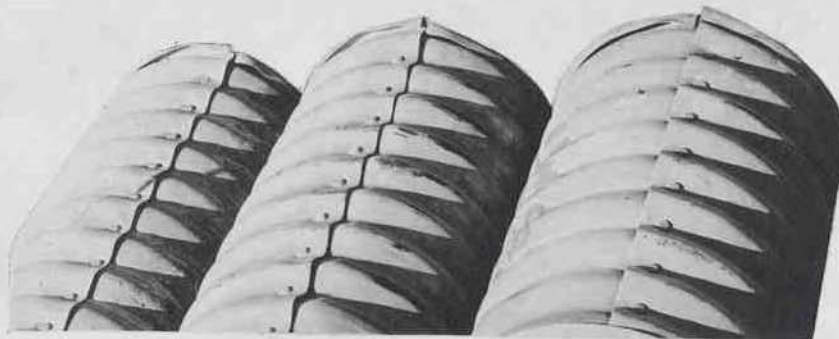
Figure 14 - Unsatisfactory

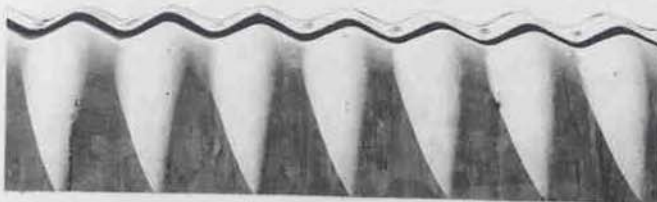
Figure 17 - Unsatisfactory
